**POTENTIALLY RESPONSIBLE PARTIES (PRP) OVERSIGHT REPORT
FOR
SAN JACINTO RIVER WASTE PITS SITE
HOUSTON, HARRIS COUNTY, TEXAS**

U.S. Environmental Protection Agency Region 6
1445 Ross Avenue
Dallas, Texas 75202

June 7, 2010

Dynamac Corporation
1202 Executive West
Richardson, Texas 75081
(214) 575-3344

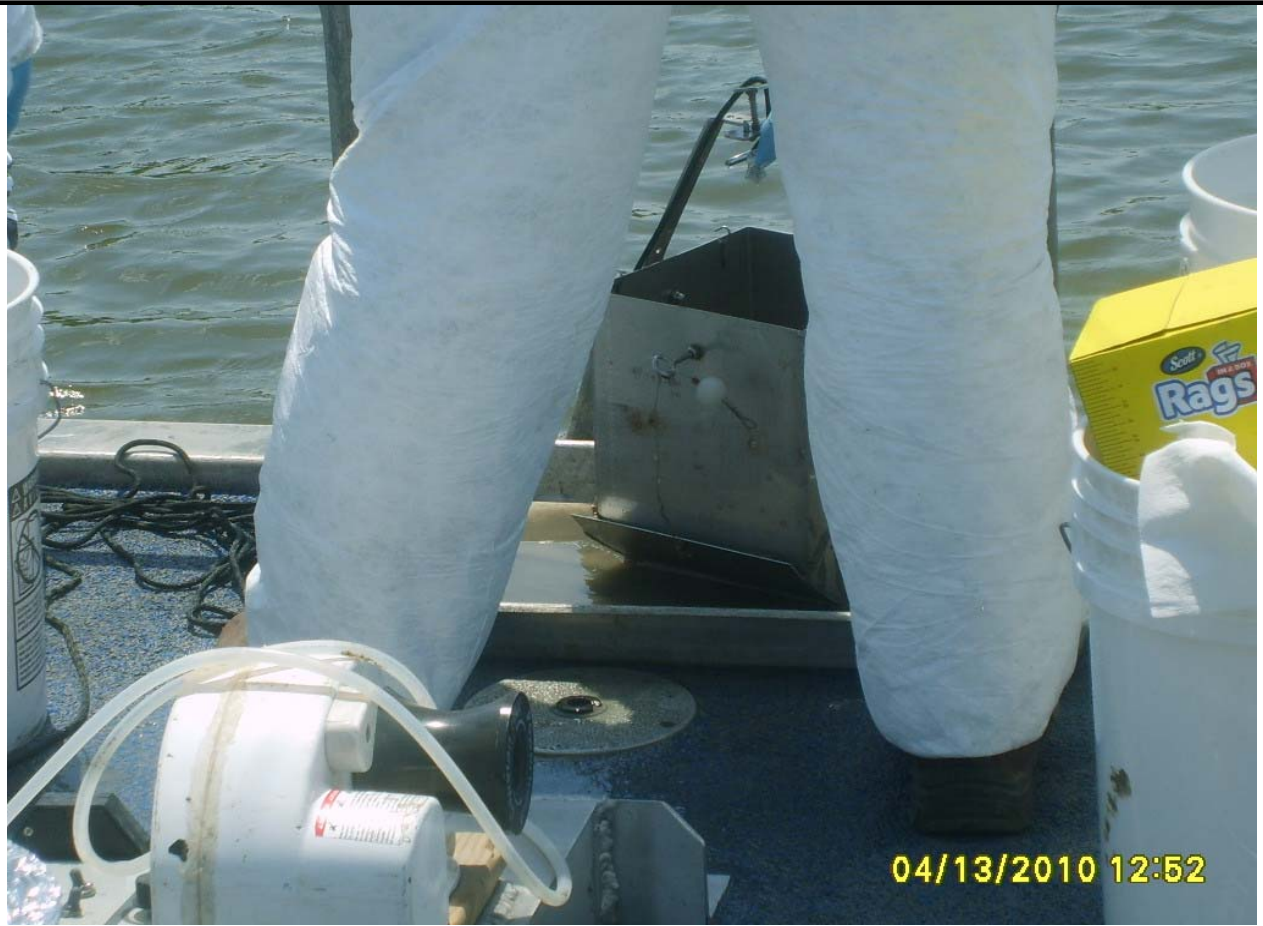
Logbook Photo #	102-0742
US EPA ID / Task Order Number	TXN000606611 / TO-0002-10-03-02
Site	San Jacinto River Waste Pits
Location Address	29.7944 N, 95.0625 W
City, State, ZIP code	Baytown, Texas
County	Harris
Direction/Orientation	Northeast
Date	April 13, 2010
Time	1252 hrs
Photographer	Karen Berecz (START)
Witness	Jason Kase (PRP Contractor – Anchor QEA)
Description:	Eckman Dredge with sample SJA3.

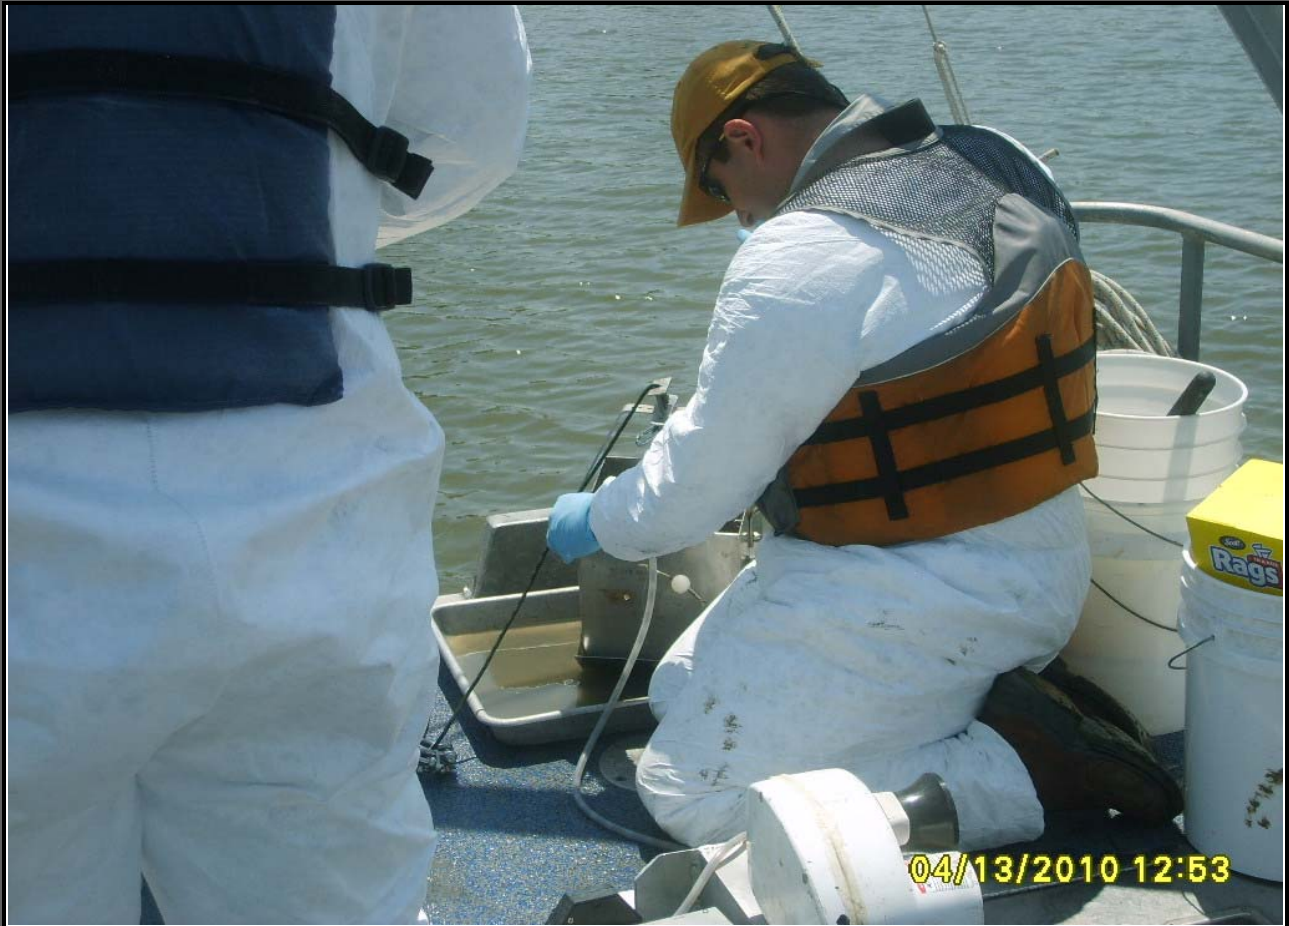
Logbook Photo #	102-0743
US EPA ID / Task Order Number	TXN000606611 / TO-0002-10-03-02
Site	San Jacinto River Waste Pits
Location Address	29.7944 N, 95.0625 W
City, State, ZIP code	Baytown, Texas
County	Harris
Direction/Orientation	Northeast
Date	April 13, 2010
Time	1253 hrs
Photographer	Karen Berecz (START)
Witness	Jason Kase (PRP Contractor – Anchor QEA)
Description:	Siphoning water off of SJA3.

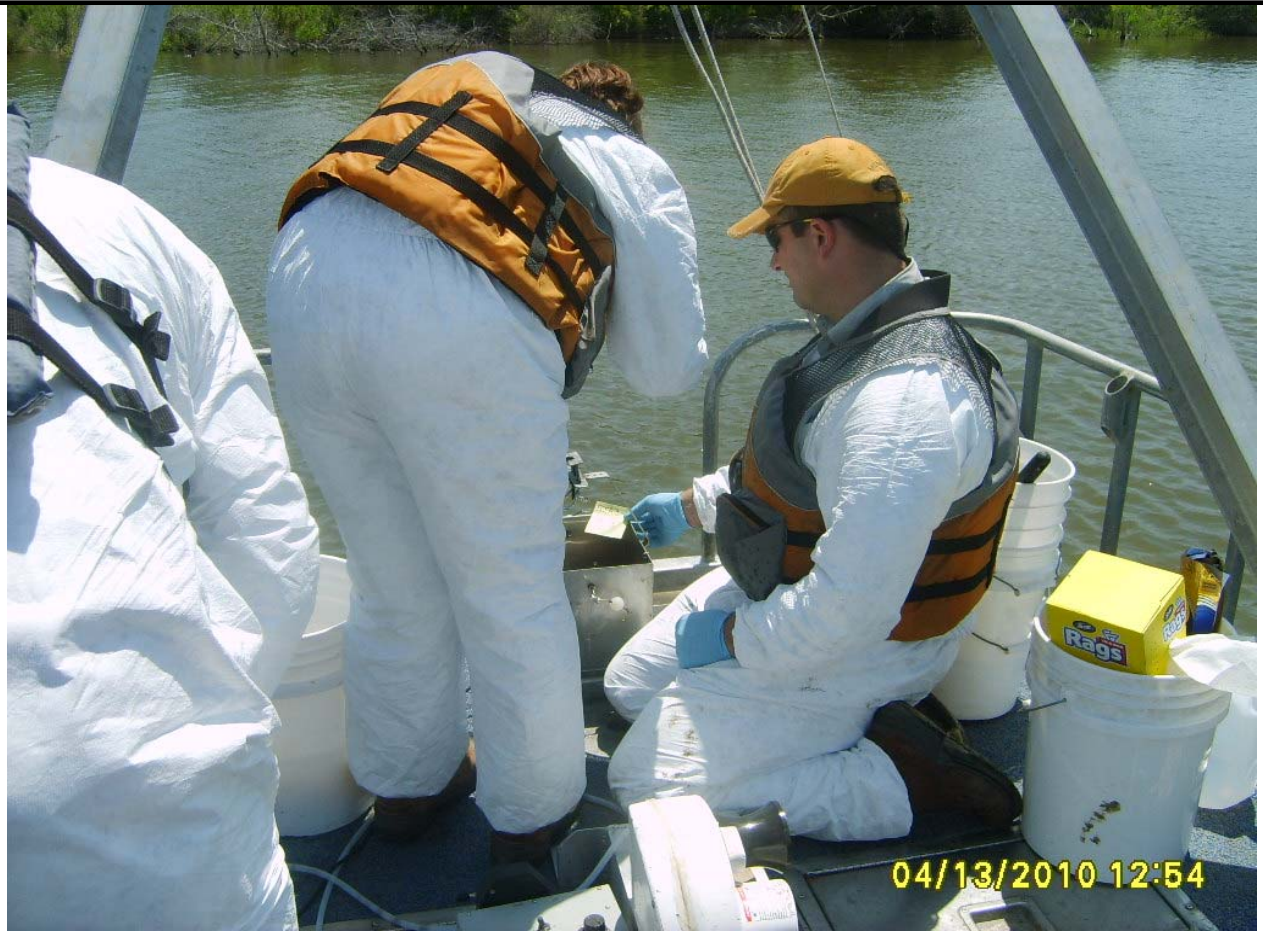
Logbook Photo #	102-0744
US EPA ID / Task Order Number	TXN000606611 / TO-0002-10-03-02
Site	San Jacinto River Waste Pits
Location Address	29.7944 N, 95.0625 W
City, State, ZIP code	Baytown, Texas
County	Harris
Direction/Orientation	Northeast
Date	April 13, 2010
Time	1254 hrs
Photographer	Karen Berecz (START)
Witness	Jason Kase (PRP Contractor – Anchor QEA)
Description: Documenting SJA3.

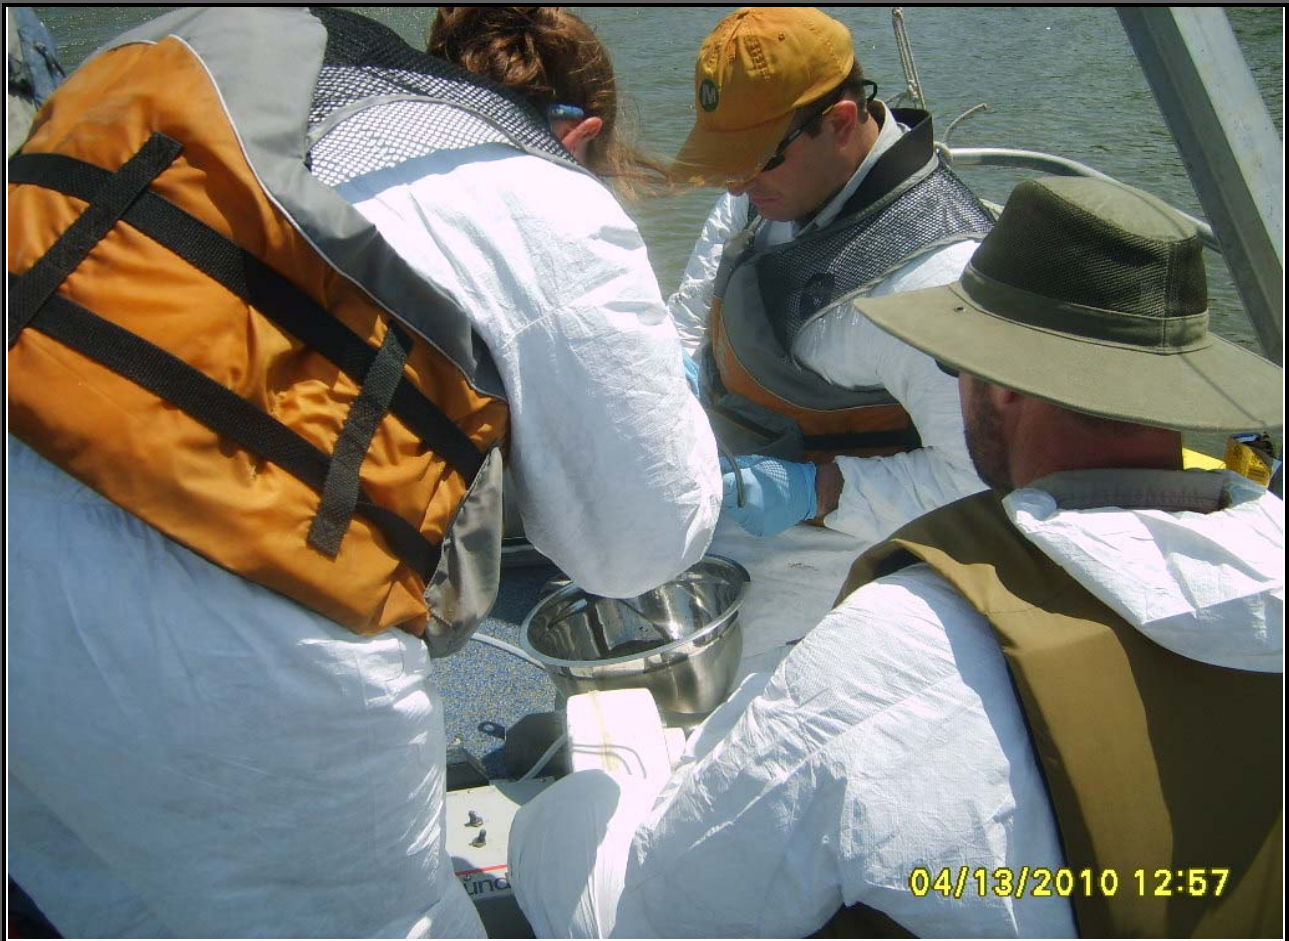
Logbook Photo #	102-0745
US EPA ID / Task Order Number	TXN000606611 / TO-0002-10-03-02
Site	San Jacinto River Waste Pits
Location Address	29.7944 N, 95.0625 W
City, State, ZIP code	Baytown, Texas
County	Harris
Direction/Orientation	Northeast
Date	April 13, 2010
Time	1257 hrs
Photographer	Karen Berecz (START)
Witness	Jason Kase (PRP Contractor – Anchor QEA)
Description:	
Documenting SJA3.

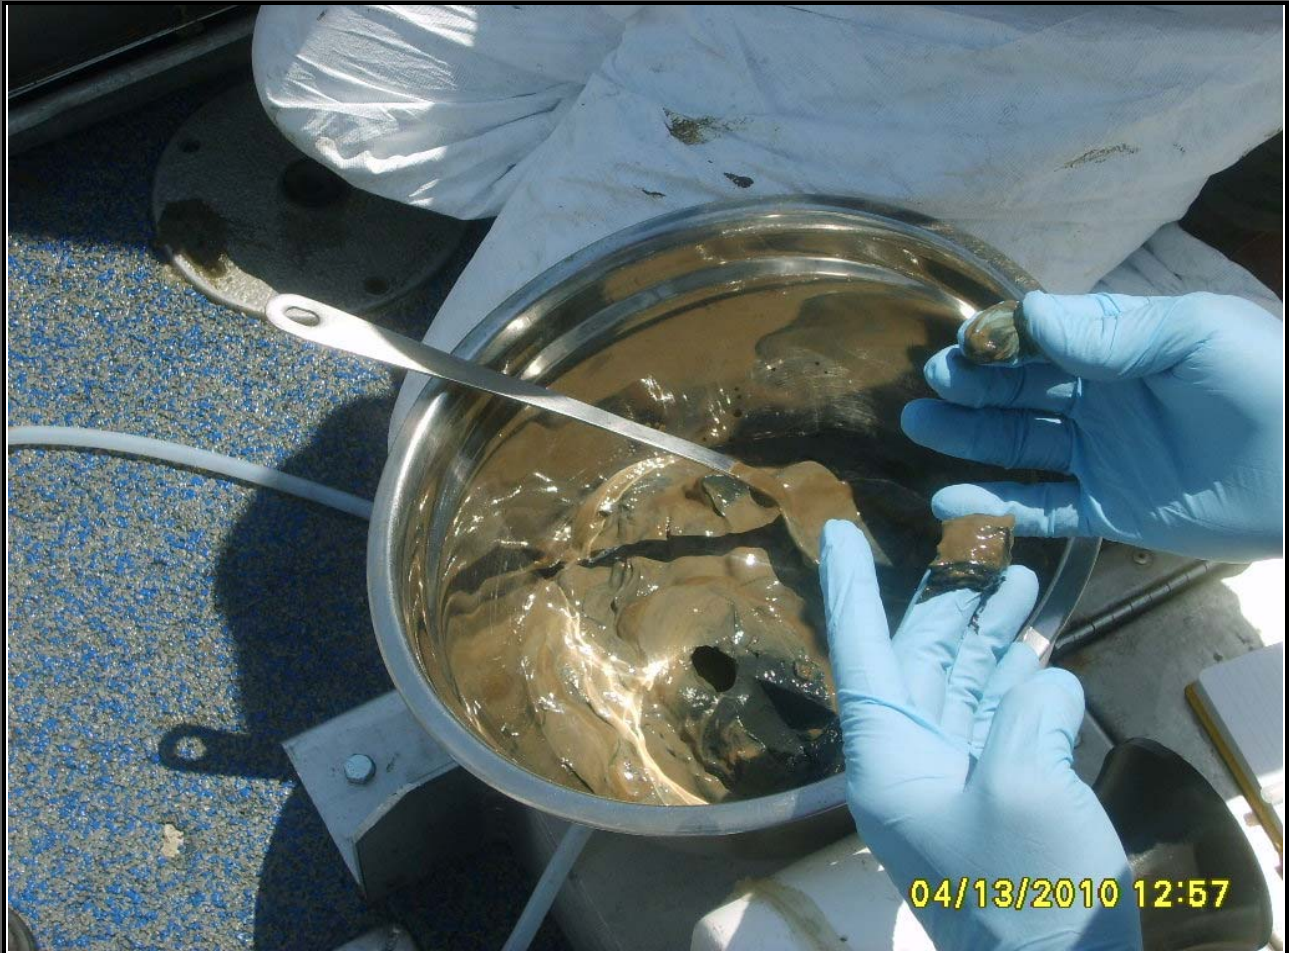
Logbook Photo #	102-0746
US EPA ID / Task Order Number	TXN000606611 / TO-0002-10-03-02
Site	San Jacinto River Waste Pits
Location Address	29.7944 N, 95.0625 W
City, State, ZIP code	Baytown, Texas
County	Harris
Direction/Orientation	Northeast
Date	April 13, 2010
Time	1257 hrs
Photographer	Karen Berecz (START)
Witness	Jason Kase (PRP Contractor – Anchor QEA)
Description:	
Sediment sample SJA3 before mixing.

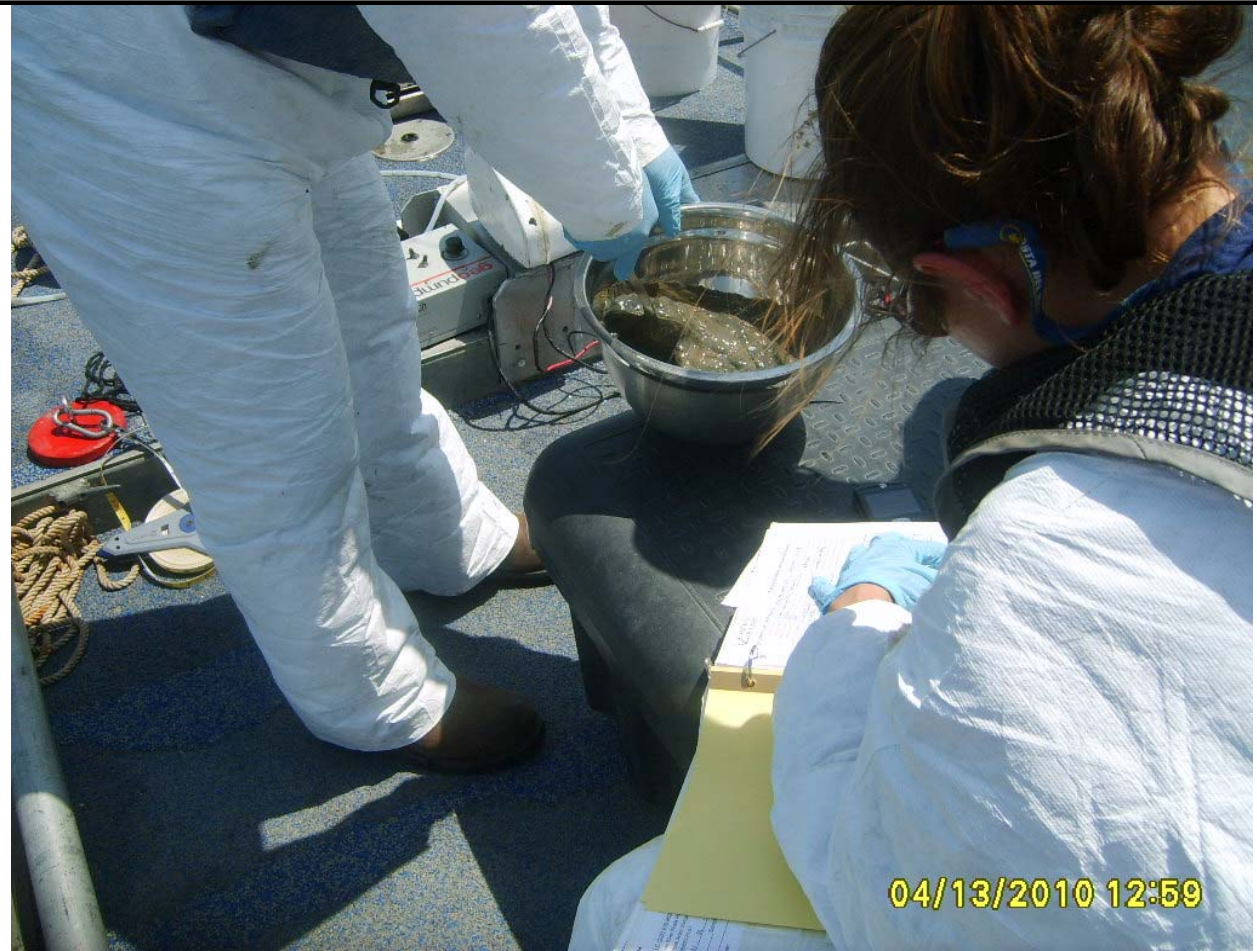
Logbook Photo #	102-0747
US EPA ID / Task Order Number	TXN000606611 / TO-0002-10-03-02
Site	San Jacinto River Waste Pits
Location Address	29.7944 N, 95.0625 W
City, State, ZIP code	Baytown, Texas
County	Harris
Direction/Orientation	Northeast
Date	April 13, 2010
Time	1259 hrs
Photographer	Karen Berecz (START)
Witness	Jason Kase (PRP Contractor – Anchor QEA)
Description:	
Mixing of sample SJA3.

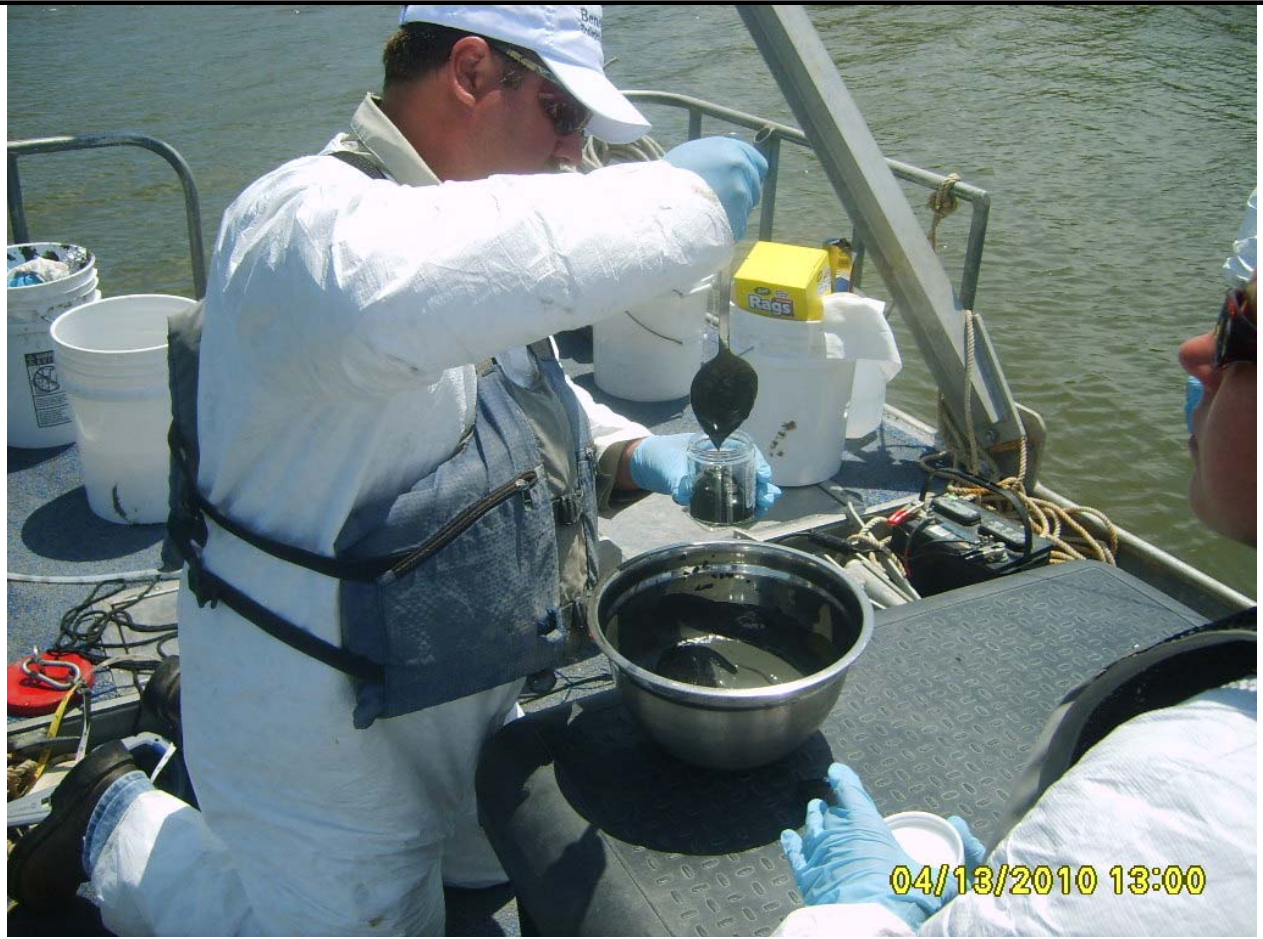
Logbook Photo #	102-048
US EPA ID / Task Order Number	TXN000606611 / TO-0002-10-03-02
Site	San Jacinto River Waste Pits
Location Address	29.7944 N, 95.0625 W
City, State, ZIP code	Baytown, Texas
County	Harris
Direction/Orientation	Northeast
Date	April 13, 2010
Time	1300 hrs
Photographer	Karen Berecz (START)
Witness	Jason Kase (PRP Contractor – Anchor QEA)
Description:	
Collecting sample at SJA3.

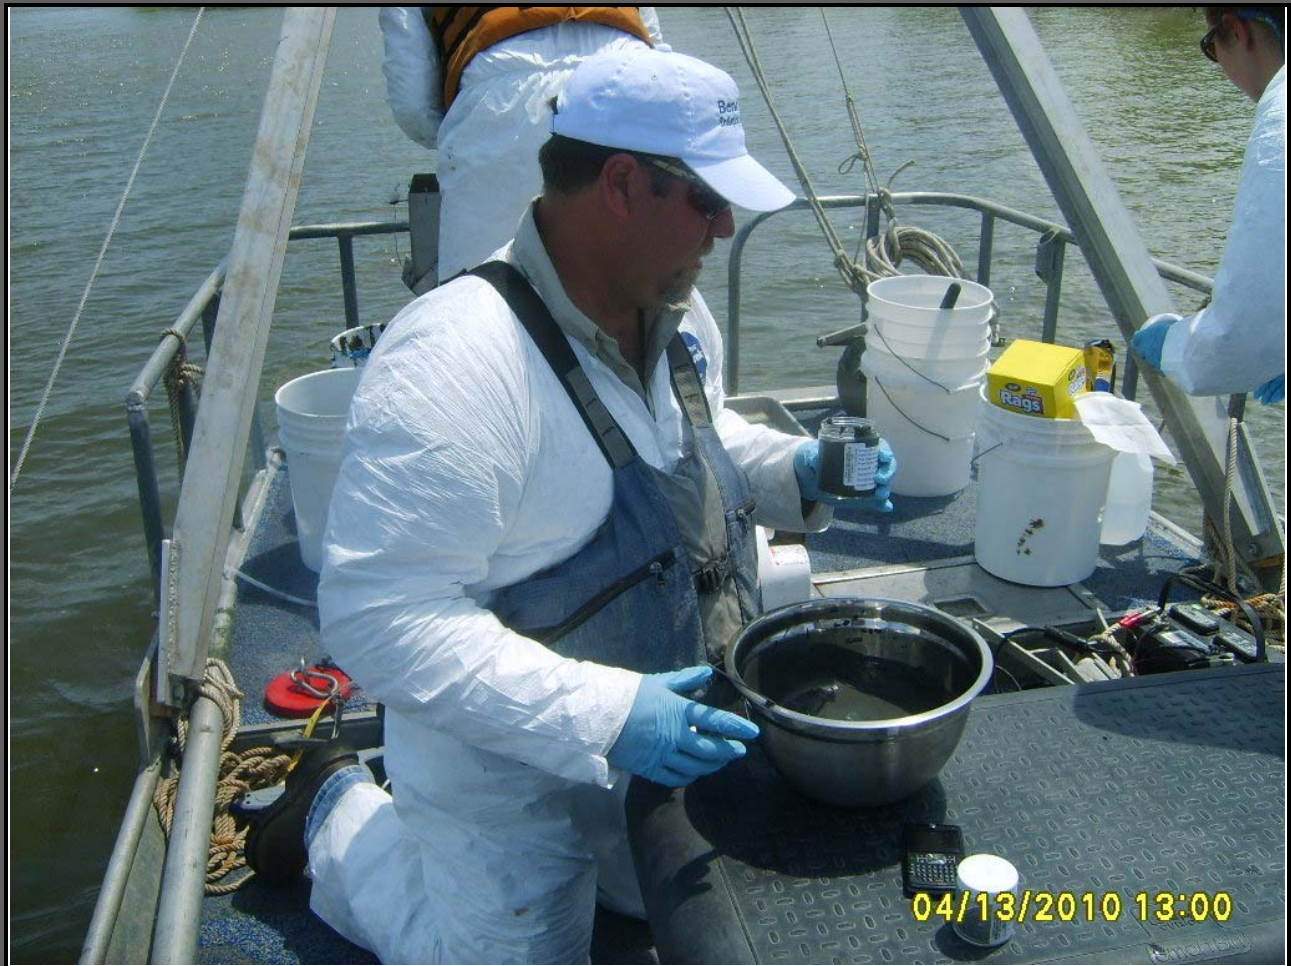
Logbook Photo #	102-0749
US EPA ID / Task Order Number	TXN000606611 / TO-0002-10-03-02
Site	San Jacinto River Waste Pits
Location Address	29.7944 N, 95.0625 W
City, State, ZIP code	Baytown, Texas
County	Harris
Direction/Orientation	Northeast
Date	April 13, 2010
Time	1300 hrs
Photographer	Karen Berecz (START)
Witness	Jason Kase (PRP Contractor – Anchor QEA)
Description:	
Collecting sample at SJA3.

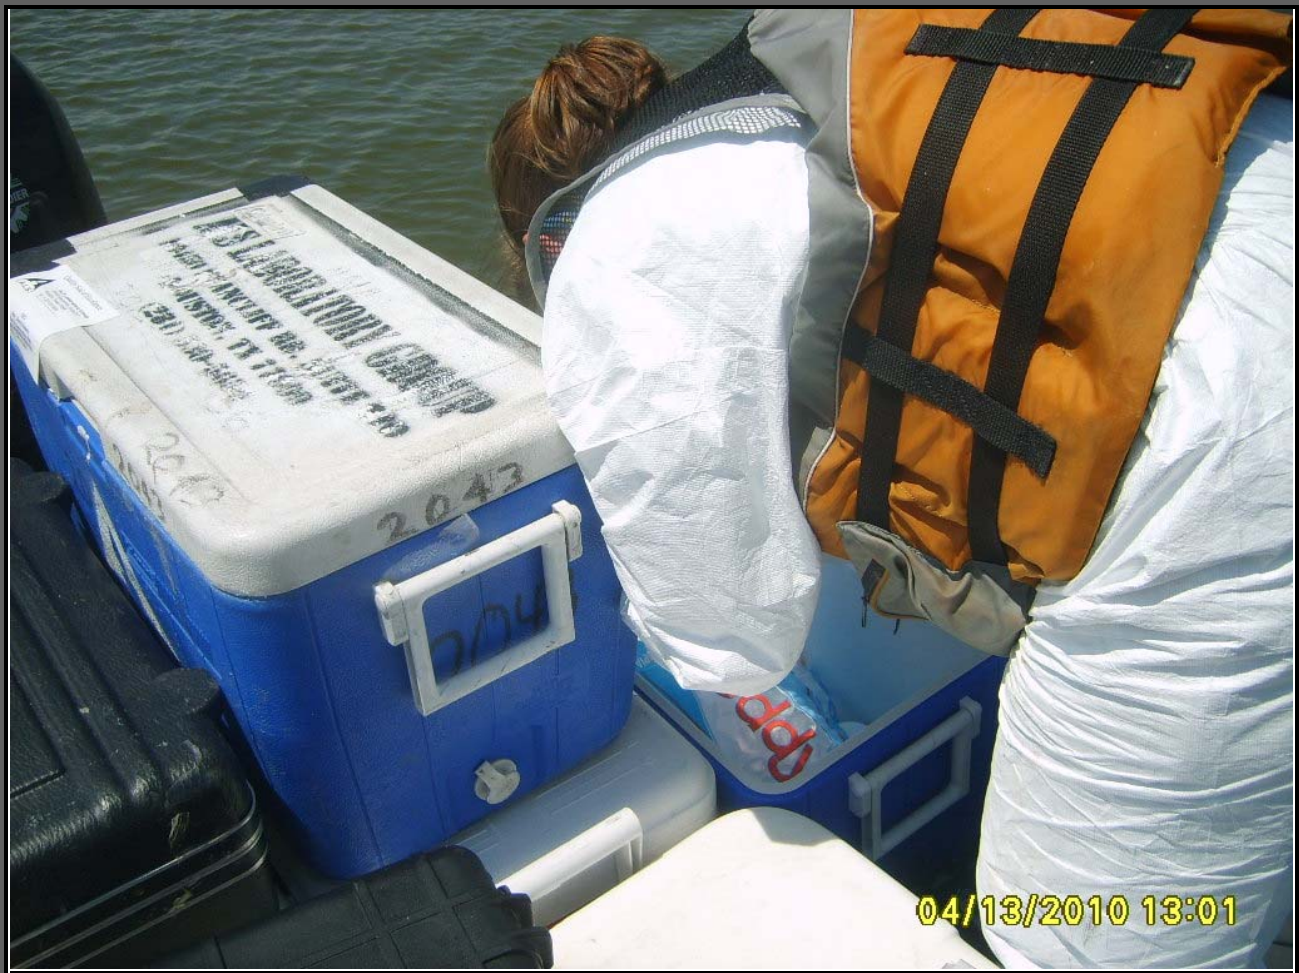
Logbook Photo #	102-0750
US EPA ID / Task Order Number	TXN000606611 / TO-0002-10-03-02
Site	San Jacinto River Waste Pits
Location Address	29.7944 N, 95.0625 W
City, State, ZIP code	Baytown, Texas
County	Harris
Direction/Orientation	West
Date	April 13, 2010
Time	1301 hrs
Photographer	Karen Berecz (START)
Witness	Jason Kase (PRP Contractor – Anchor QEA)
Description:	
Packing samples in cooler with ice.

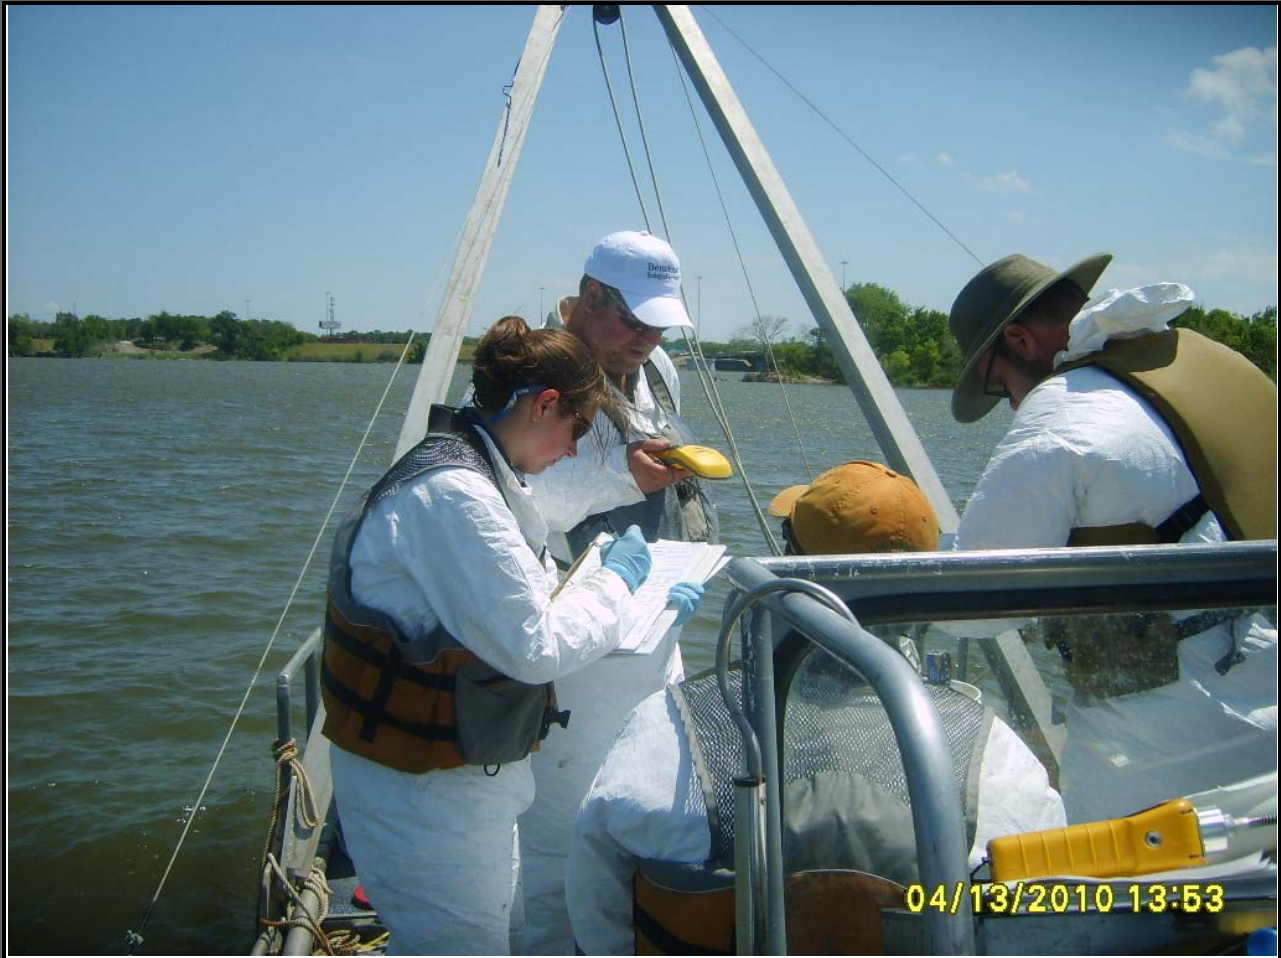
Logbook Photo #	102-0751
US EPA ID / Task Order Number	TXN000606611 / TO-0002-10-03-02
Site	San Jacinto River Waste Pits
Location Address	29.7944 N, 95.0625 W
City, State, ZIP code	Baytown, Texas
County	Harris
Direction/Orientation	Northeast
Date	April 13, 2010
Time	1353 hrs
Photographer	Karen Berecz (START)
Witness	Jason Kase (PRP Contractor – Anchor QEA)
Description:	
Reading off GPS coordinates at station SJB5.

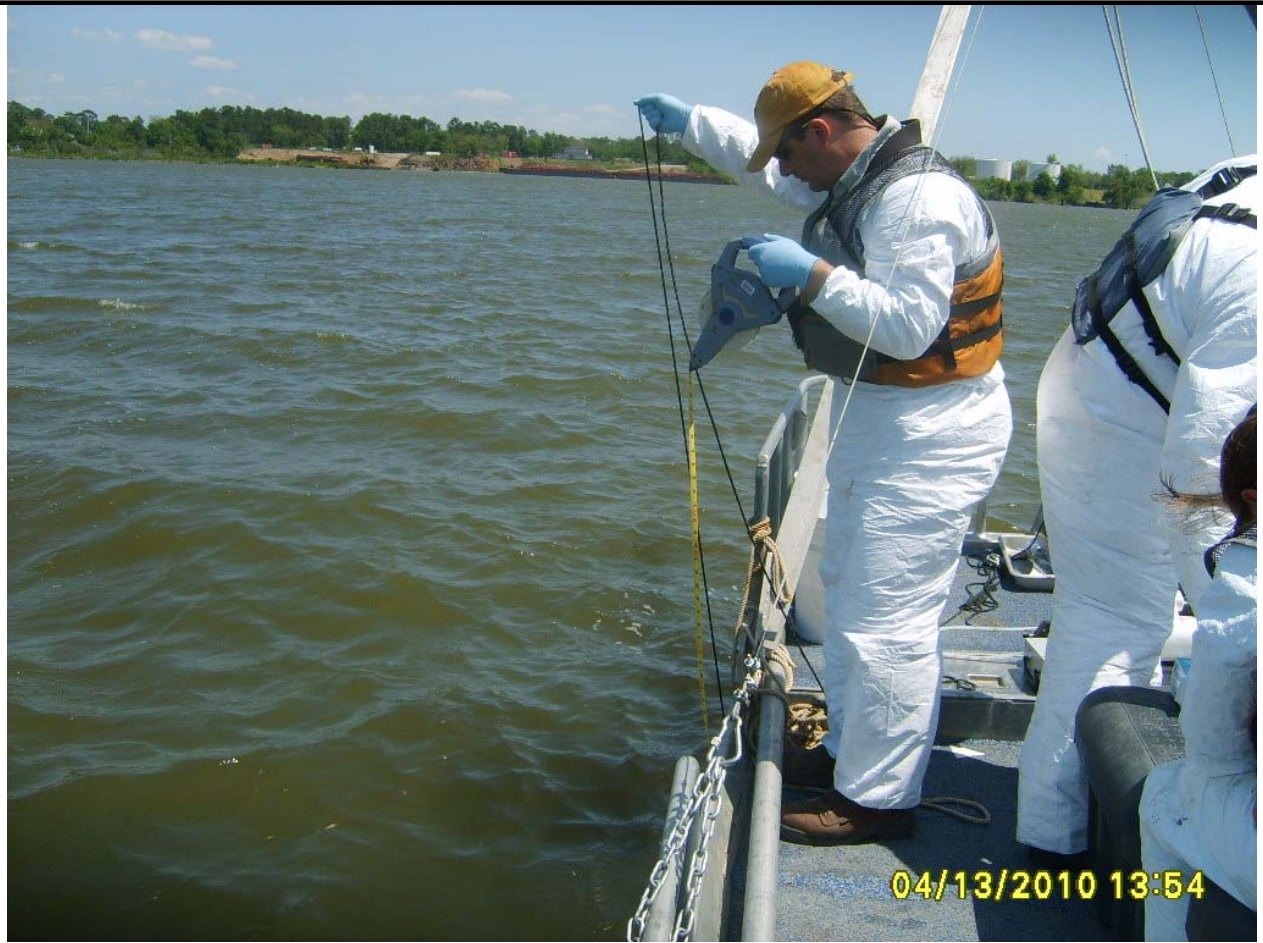
Logbook Photo #	102-0752
US EPA ID / Task Order Number	TXN000606611 / TO-0002-10-03-02
Site	San Jacinto River Waste Pits
Location Address	29.7944 N, 95.0625 W
City, State, ZIP code	Baytown, Texas
County	Harris
Direction/Orientation	Northeast
Date	April 13, 2010
Time	1354 hrs
Photographer	Karen Berecz (START)
Witness	Jason Kase (PRP Contractor – Anchor QEA)
Description: Getting a water depth at SJB5.

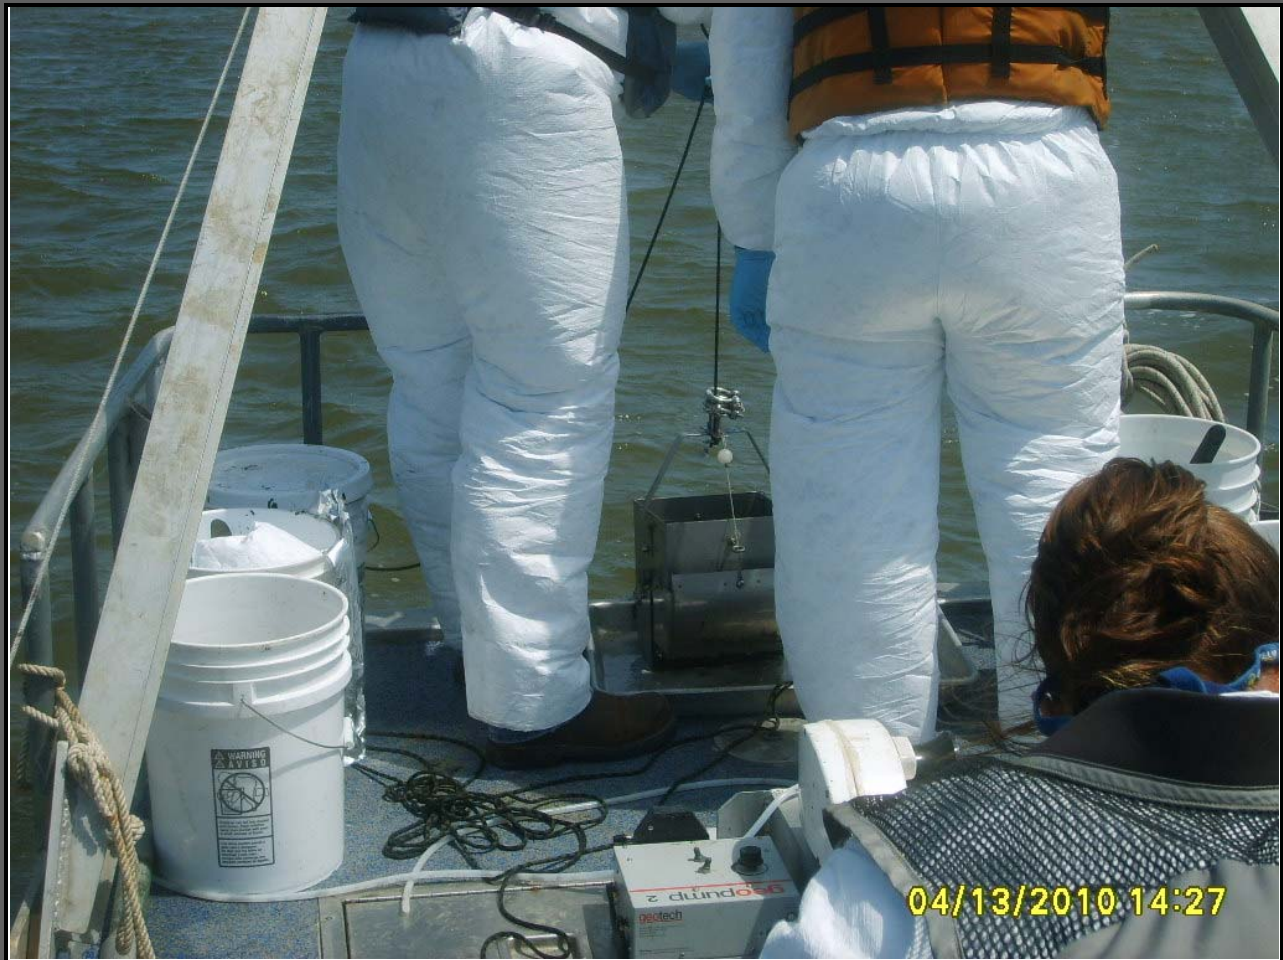
Logbook Photo #	102-0753
US EPA ID / Task Order Number	TXN000606611 / TO-0002-10-03-02
Site	San Jacinto River Waste Pits
Location Address	29.7944 N, 95.0625 W
City, State, ZIP code	Baytown, Texas
County	Harris
Direction/Orientation	Northeast
Date	April 13, 2010
Time	1427 hrs
Photographer	Karen Berecz (START)
Witness	Jason Kase (PRP Contractor – Anchor QEA)
Description:	Preparing to drop sampler at SJB5.

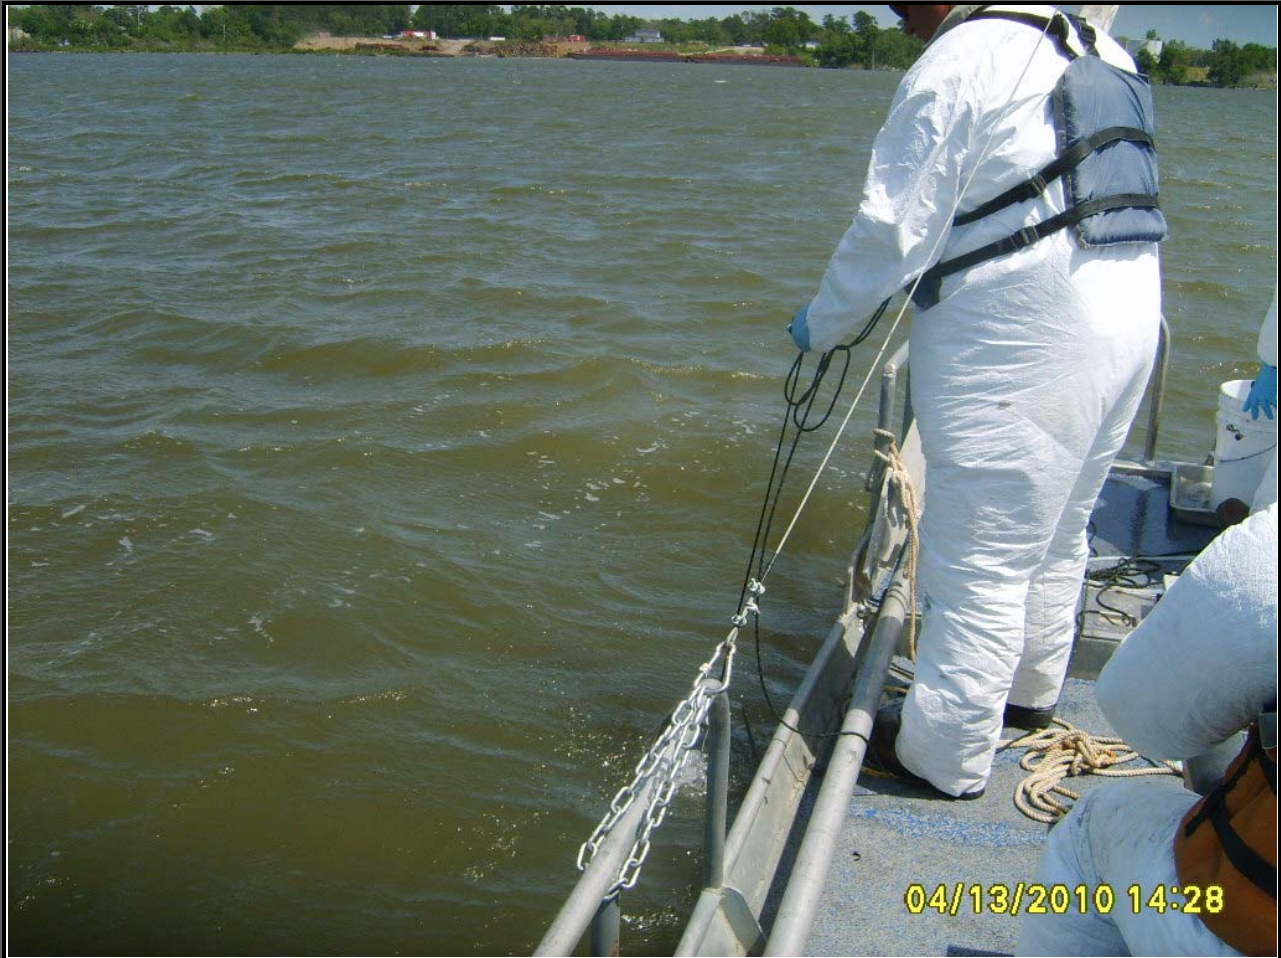
Logbook Photo #	102-0754
US EPA ID / Task Order Number	TXN000606611 / TO-0002-10-03-02
Site	San Jacinto River Waste Pits
Location Address	29.7944 N, 95.0625 W
City, State, ZIP code	Baytown, Texas
County	Harris
Direction/Orientation	Northeast
Date	April 13, 2010
Time	1427 hrs
Photographer	Karen Berecz (START)
Witness	Jason Kase (PRP Contractor – Anchor QEA)
Description:	
Dumping sample SJB5 as waste.

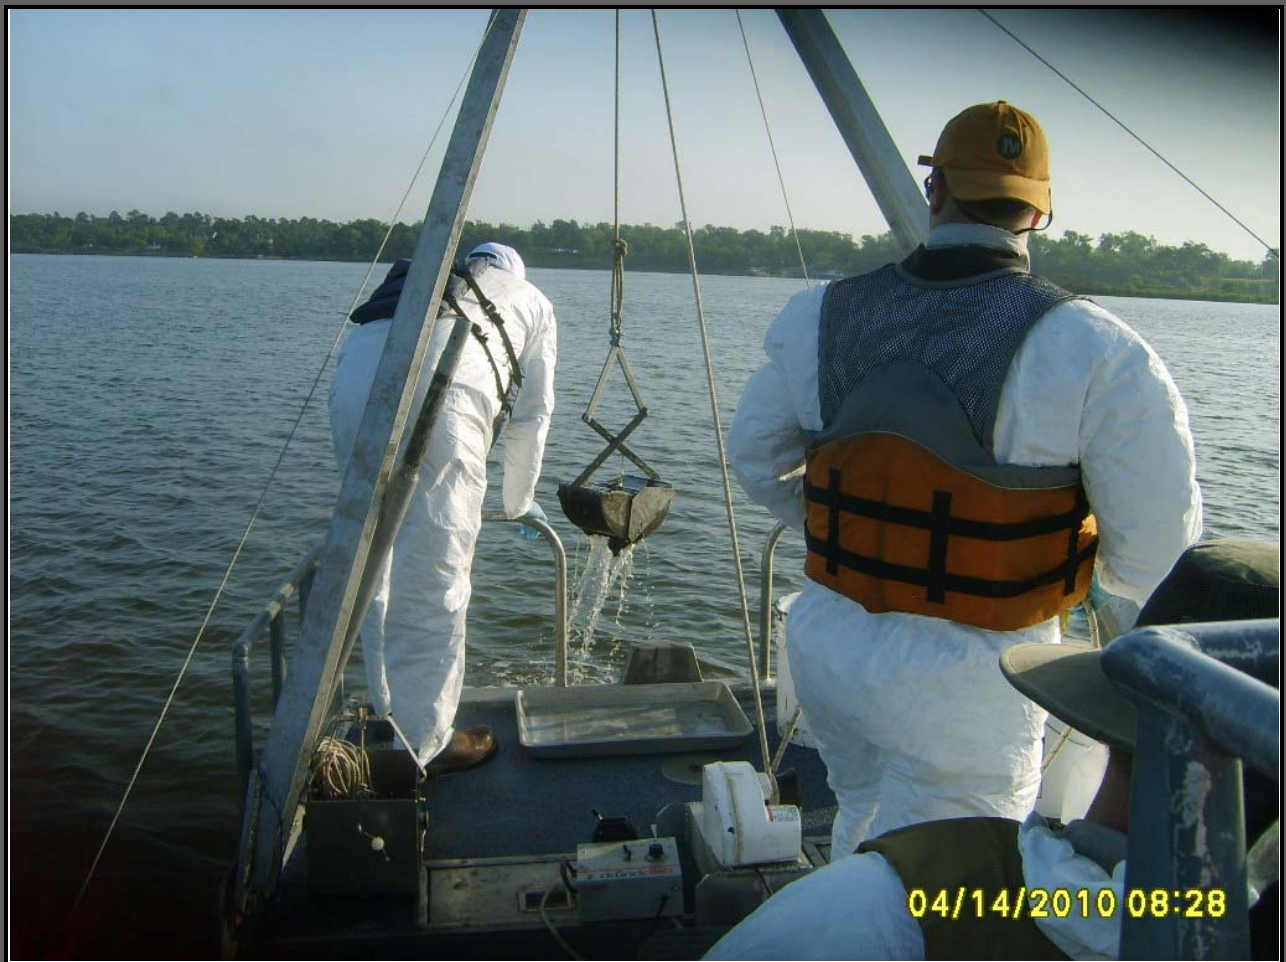
PHOTO 102-0761. LOOKING NW AT NEAL
DUMPING INADEQUATE SAMPLE FROM
PUNAR INTO 15W BUCKET, FROM SJCS

DUE TO POOR SAMPLE RETRIEVAL AT SJCS
MOVING TO SJCH TO SEE HOW SEDIMENT
CONDITIONS ARE THERE.

Logbook Photo #	102-0761
US EPA ID / Task Order Number	TXN000606611 / TO-0002-10-03-02
Site	San Jacinto River Waste Pits
Location Address	29.7944 N, 95.0625 W
City, State, ZIP code	Baytown, Texas
County	Harris
Direction/Orientation	Northwest
Date	April 14, 2010
Time	0821 hrs
Photographer	Karen Berecz (START)
Witness	Jason Kase (PRP Contractor – Anchor QEA)
Description:	
Dumping inadequate sample as waste into container from SJC5.

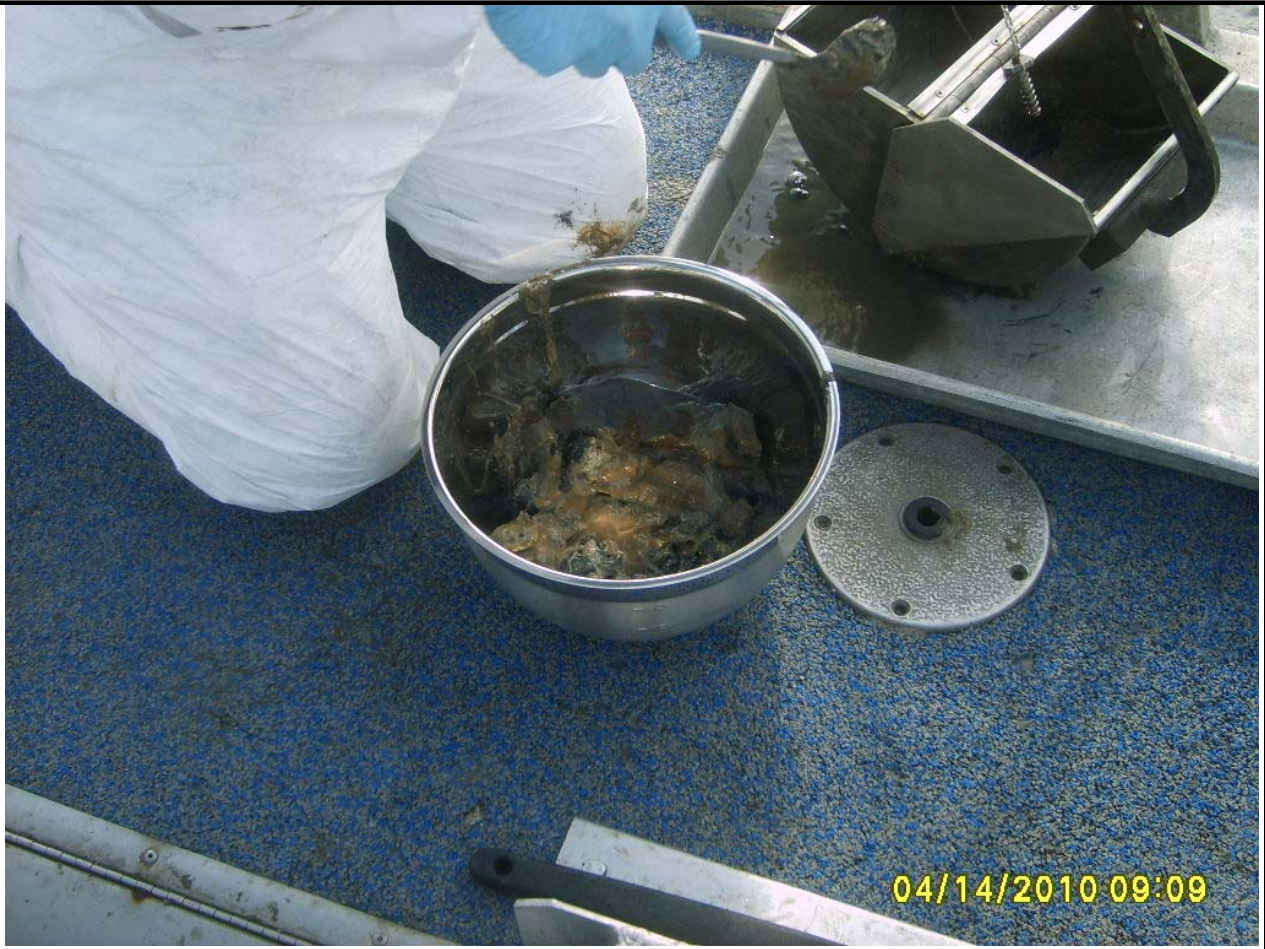
Logbook Photo #	102-0765
US EPA ID / Task Order Number	TXN000606611 / TO-0002-10-03-02
Site	San Jacinto River Waste Pits
Location Address	29.7944 N, 95.0625 W
City, State, ZIP code	Baytown, Texas
County	Harris
Direction/Orientation	Northeast
Date	April 14, 2010
Time	0909 hrs
Photographer	Karen Berecz (START)
Witness	Jason Kase (PRP Contractor – Anchor QEA)
Description:	
Scooping out shells from Sample SJC4.

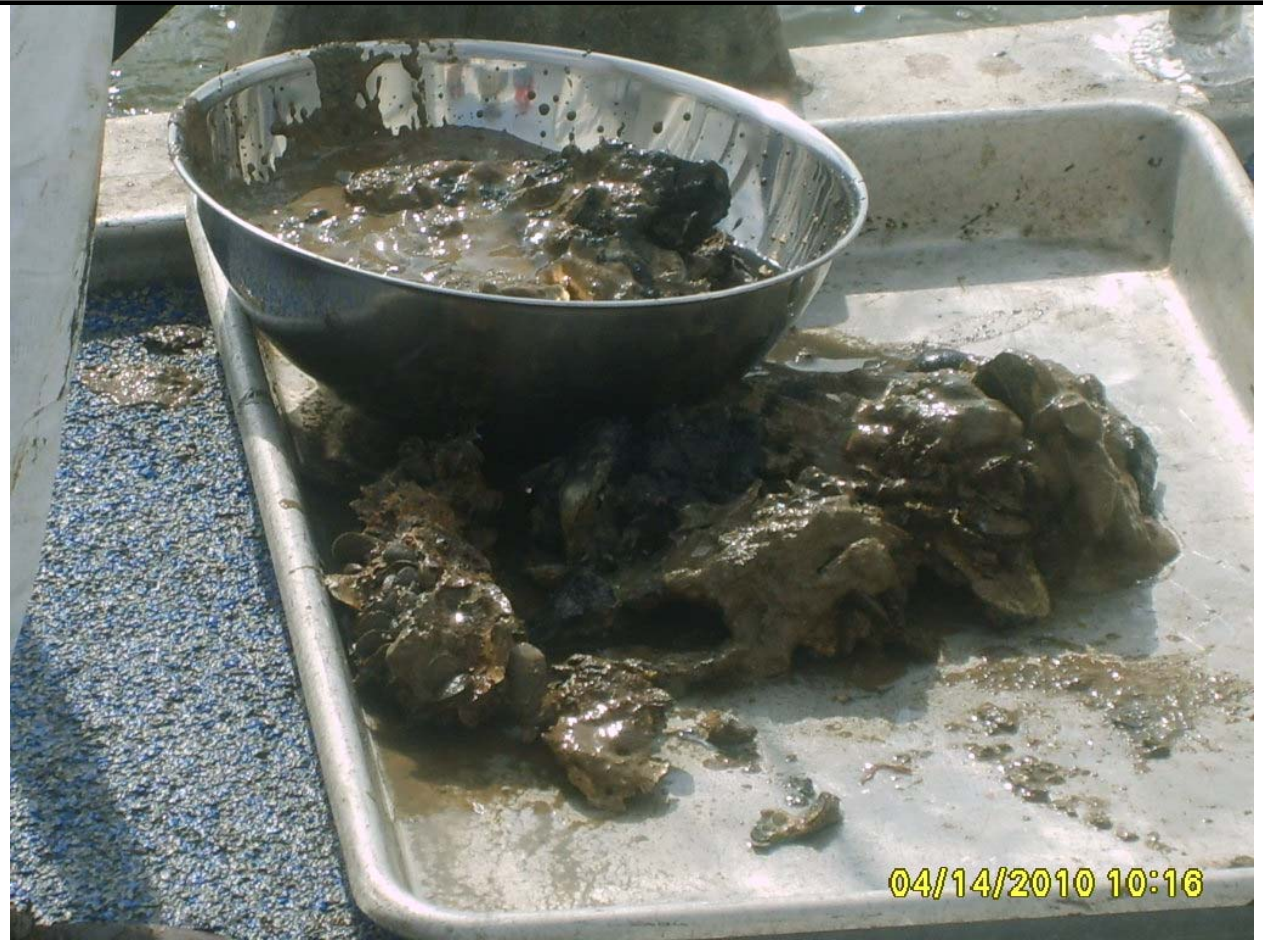
DO THREE GRAB SAMPLES WITH PUNAL TO OBTAIN AN ADEQUATE AMOUNT OF SEDIMENT TO SAMPLE. SAMPLING FAILS WITHIN ACCEPTABLE CRITERIA. ALL THREE GRAB SAMPLES WERE COMBINED TO OBTAIN SAMPLES FOR ANCHOR AND SOCI. JASON AGAIN HAS TO SCOOP OUT SHELL FRAGMENTS FROM SAMPLE, DUE TO LOCATION STCS BEING ATOP OF AN OYSTER BED.

PHOTO 102-0714. LOOKING NE. JASON
RELEASING GRAB SAMPLE #3 INTO
STAINLESS STEEL BOWL FROM PONAL AT STCS
COMPLETE SAMPLING AT STCS. ALL
MODIFIED PROCEDURES AND METHODS ARE
BEING FOLLOWED.

Logbook Photo #	102-0774
US EPA ID / Task Order Number	TXN000606611 / TO-0002-10-03-02
Site	San Jacinto River Waste Pits
Location Address	29.7944 N, 95.0625 W
City, State, ZIP code	Baytown, Texas
County	Harris
Direction/Orientation	Northeast
Date	April 14, 2010
Time	0646 hrs
Photographer	Karen Berecz (START)
Witness	Jason Kase (PRP Contractor – Anchor QEA)
Description:	
Releasing grab sample #3 into bowl from Ponar at SJC5.

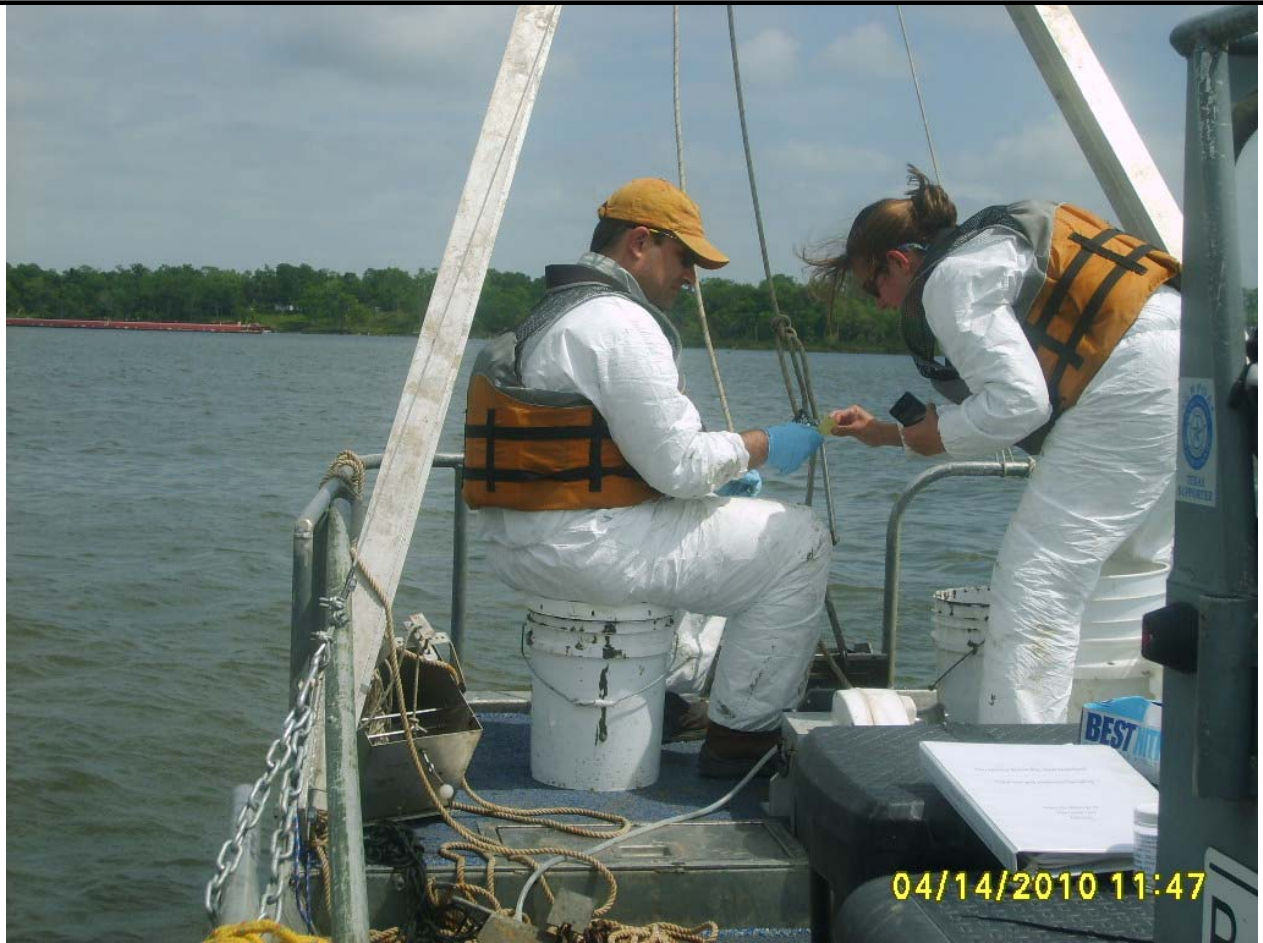
Logbook Photo #	102-0781
US EPA ID / Task Order Number	TXN000606611 / TO-0002-10-03-02
Site	San Jacinto River Waste Pits
Location Address	29.7944 N, 95.0625 W
City, State, ZIP code	Baytown, Texas
County	Harris
Direction/Orientation	East
Date	April 14, 2010
Time	1145 hrs
Photographer	Karen Berecz (START)
Witness	Jason Kase (PRP Contractor – Anchor QEA)
Description:	
Siphoning water from Ponar sampler prior to collecting sample at SJD3.
